External Flashover of Generator Circuit Breaker in Coastal Power Plants having Air Insulated Switchyard

A. Brief Description of the Plant and the Problem

B. Incidence

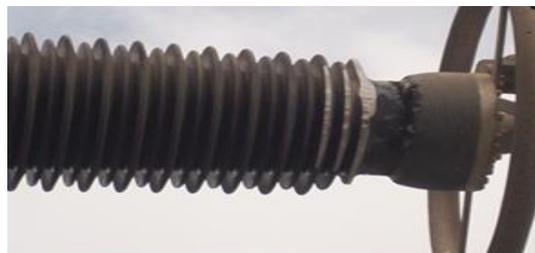
On 30/06/2012, at about 04.22 Hrs, the 330 MW Unit-4 was getting ready for synchronization with the grid after a forced outage. The Turbine Generator (TG) set was at 3000 rpm and the Generator isolator in switchyard was in closed condition. As soon as the voltage was built up to about 24 KV, external flashover took place across the Y-Phase Generator Circuit Breaker contacts with heavy sound and the insulator housing of the contact got broken. The unit got tripped on actuation of Generator Protection.

Photograph-1: Damaged Breaker Pole

From the above observation and seeing the physical condition of the Circuit Breaker, it was concluded that the flashover in Y-Pole was due to external contamination in saline atmosphere. Since the machine was ready for synchronization, one side of the breaker was having grid voltage and other side voltage i.e. machine voltage was varying with respect to the grid voltage. Under such condition, breakdown voltage was reached across the breaker pole and flashover took place externally.

- Line isolators should be closed just prior to voltage build-up and when machine is ready for synchronization.
- Generator Breakers used in coastal areas should be designed with higher creepage distance (about 35 mm/ KV) or else use creep extenders.
- Regular cleaning of the insulator (Hot line washing with DM water) to avoid salt deposition.
- Avoid synchronization when humidity is high.

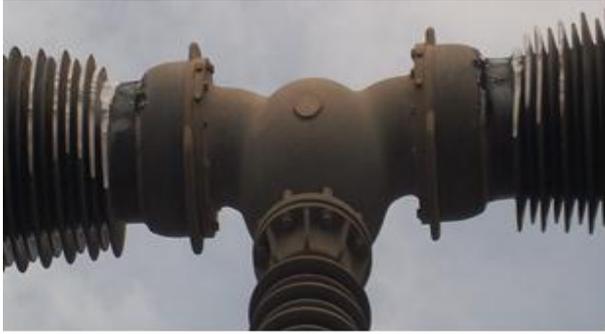
Photograph-2: Damaged Breaker Pole

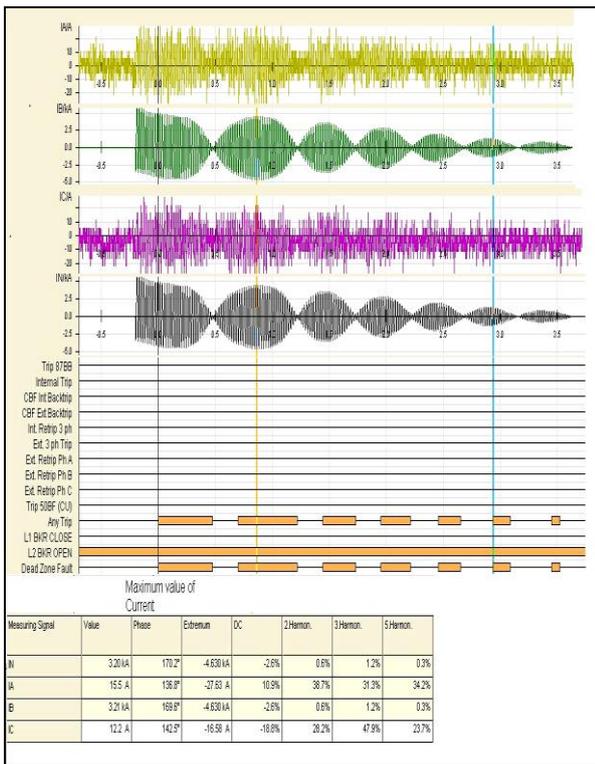
The Disturbance Recorder (DR) chart of Generator placed below as Fig. 1 clearly showed flashover of Y-Phase CB. The current measured was 3.21 kA (RMS) and 4.63 kA (Peak).

Figure 1. Generator disturbance recorder chart

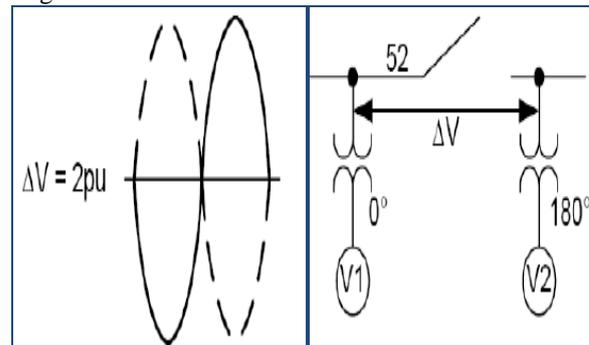
During synchronization process, the out-of-phase voltage angle between contacts changes from 0 to 360 degrees continuously. Voltage across the breaker contacts reaches its maximum instantaneous value when the angle difference between the voltages is 180 degrees as shown in Fig. 2 below-

Figure 2. Voltage across breaker contacts

During out of phase condition, i.e. (voltage vectors 180 degree apart), net voltage across breaker contacts = 462 KV (RMS) and 654 KV (Peak)

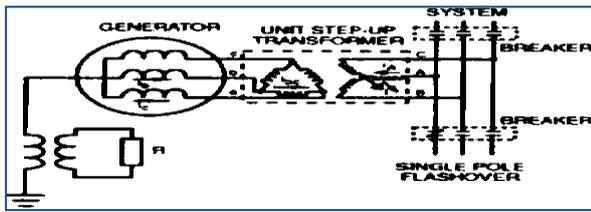
The current flow during single phase CB flashover has been shown below in Fig. 3.

Figure 3. Current in case of single phase CB flashover

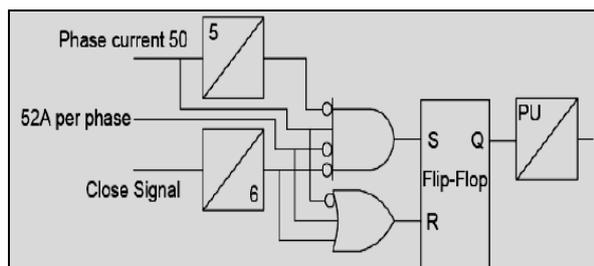
Time Limits and Close-Signal Monitoring to Detect Flashover is shown in Fig. 5 below.

Figure 5. Logic for Detection of Breaker Flashover

- Phase current greater than set value and no current five cycles before the start of the scheme.
- Breaker auxiliary contact open.

- No closing signal to breaker at least six cycles before the start.

Allows scheme operation only if latch conditions occur in the first five cycles after current flows in the breaker. No mal-operation where a breaker auxiliary signal is lost during normal operation with the breaker closed and residual or phase currents present.

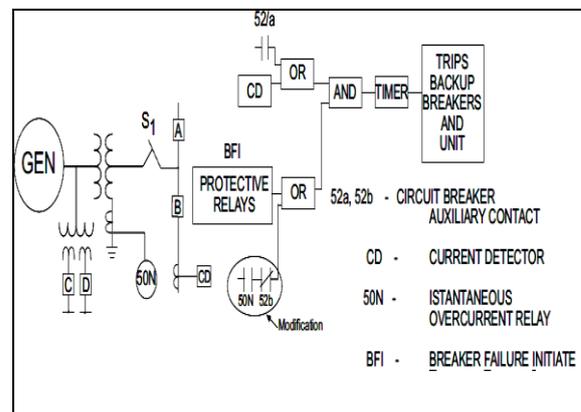
One approach used to speed the detection of a breaker flashover is to modify the breaker failure scheme as shown in Fig-6. An instantaneous overcurrent relay (50N) is connected in the neutral of the generator step-up transformer and is set to respond to an Extra High Voltage (EHV) breaker pole flashover current. The relay output is supervised by the generator breaker “52B” NC contact providing an additional start to the breaker failure scheme. When the generator breaker is open and one or two poles of the breaker flash over, the resulting transformer neutral current is detected by the 50N relay without the delay that would be associated with a negative sequence relay. The current detectors (CD) associated with the generator breaker scheme must be set with sufficient sensitivity to detect this flashover condition.

Figure 6. Speedy detection of Breaker Flashover

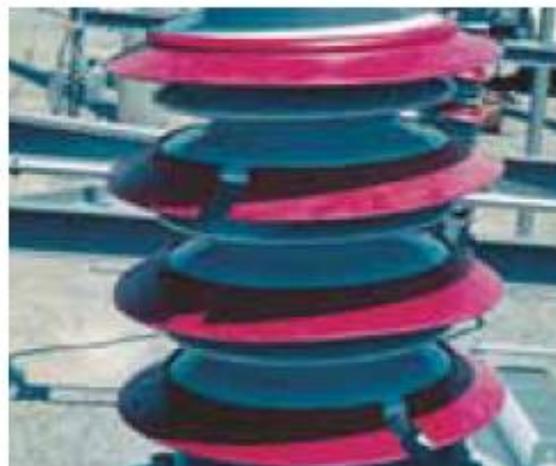
High Voltage Wraparound Creepage Extenders are designed for use in highly contaminated environments. The wrap around type cold applied variant is retained in place on the collar of the existing porcelain disc with the help of pressure sensitive mastic. Typically application of one extends nominal creepage distance of the existing insulator by 100 mm. It is also quite imperative to note that once 20% of the creepage is added with the help of extender, pollution withstand ability of the original insulator without creating electrical flashover enhances by more than double. The extenders are designed to be resistant to conventional spray washing techniques and will withstand most normal handling, abuse, and extreme weather conditions. Photograph-3 below shows a typical bushing fitted with Wraparound Creepage extender.

Photograph-3: HV Wraparound Creepage Extender
